# Hydrogen embrittlement in tantalum

Marc Cook – Technical consultant / Materials Specialist

Tricor Metals – Wooster OH

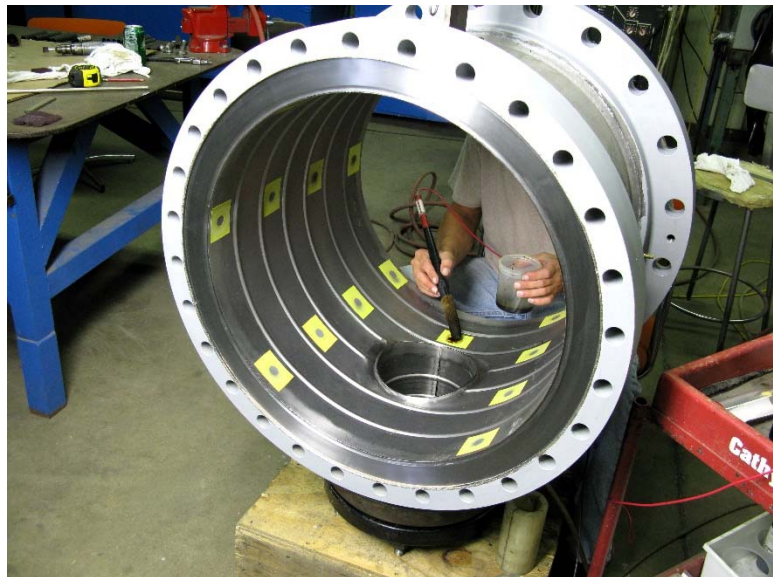
Figure 1 Platinum spots being electroplated onto a tantalum-lined heat exchanger bonnet in Tricor's shop.

It was discovered in the 1960's that coupling tantalum with platinum group metals reduces the tendency of tantalum to absorb hydrogen. The paper found a surface area ratio of 1:10,000 was sufficient to substantially reduce the amount of hydrogen uptake/embrittlement at very aggressive conditions. Based on this prior work, the convention has become to apply platinum plating in spots on tantalum liners when specified at a ration of 1:1000 (10:1 safety factor).

It is important that a fabricator utilizes best practices in applying the platinum coating for it to stay in place and remain effective. Tricor recommended utilizing tests described by ASTM B571 for ensuring the quality of platinum plating is sufficient.
